WL-TR-97-2053

THIN DENSE CHROME BEARING INSERTION
PROGRAM

GE AIRCRAFT ENGINES
ADVANCED ENGINEERING PROGRAMS DEPT
ONE NEUMANN WAY
CINCINNATI OH 45215-6301

FINAL REPORT FOR 03/01/92-12/01/96

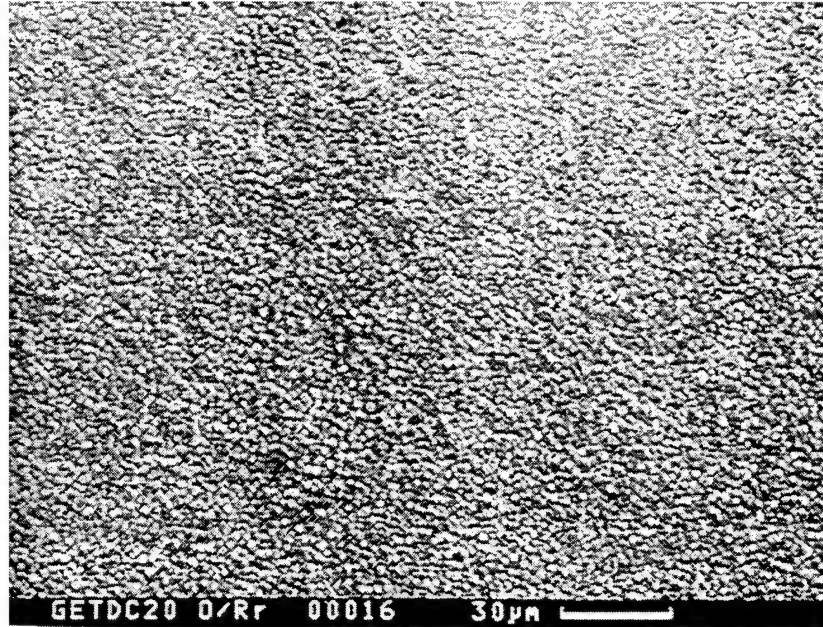
500X

Figure 20. Thermal Shock Specimen GE TDC 20 SEM Photo of Position 1 (0°) in Raceway (MRC Round 1). *TDC is in good condition.*

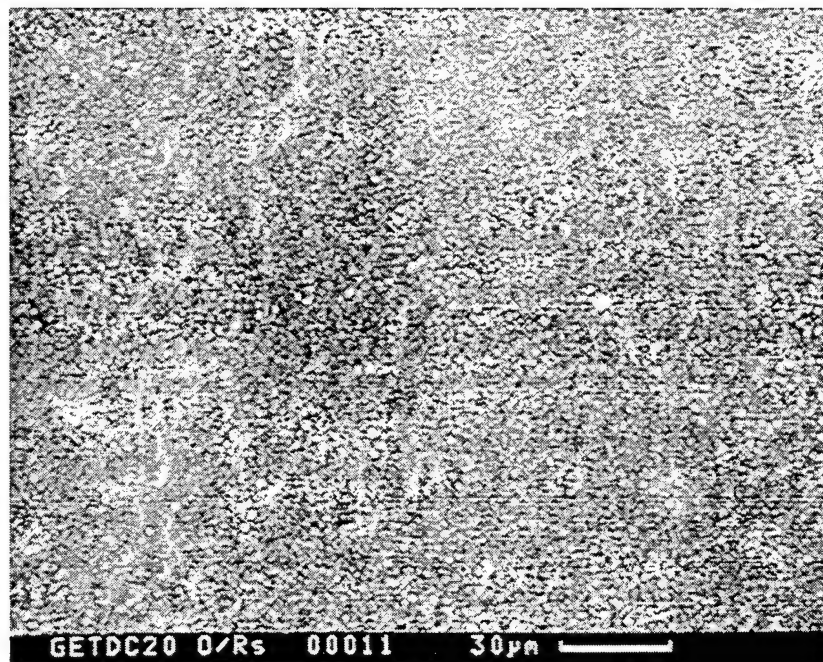
500X

Figure 21. Thermal Shock Specimen GE TDC 20 SEM Photo of Position 1 (0°) in Shoulder (MRC Round 1). *TDC is in good condition.*

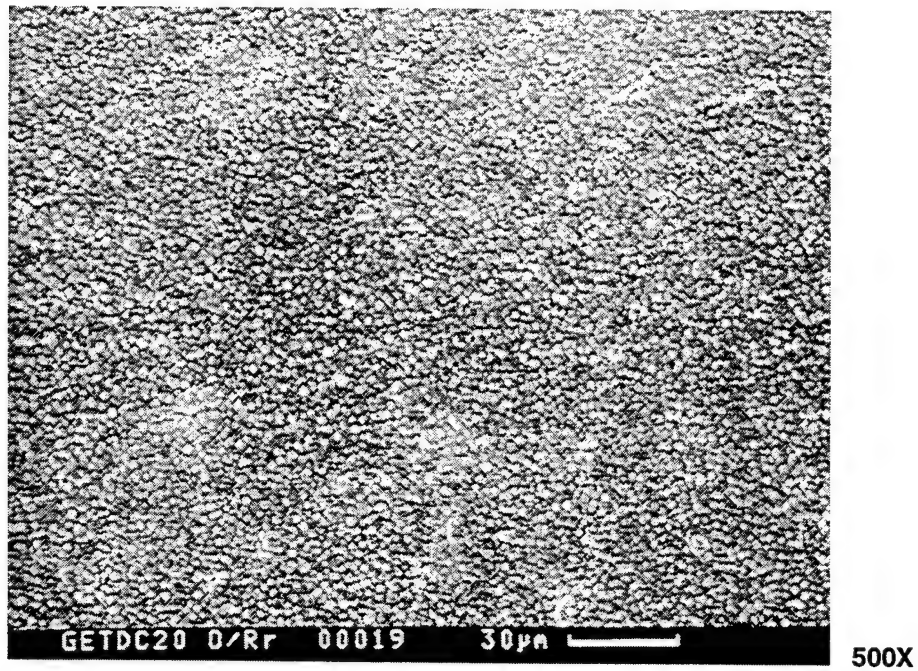
Figure 22. Thermal Shock Specimen GE TDC 20 SEM Photo of Position 2 (90°) in Raceway (MRC Round 1). *TDC is in good condition.*

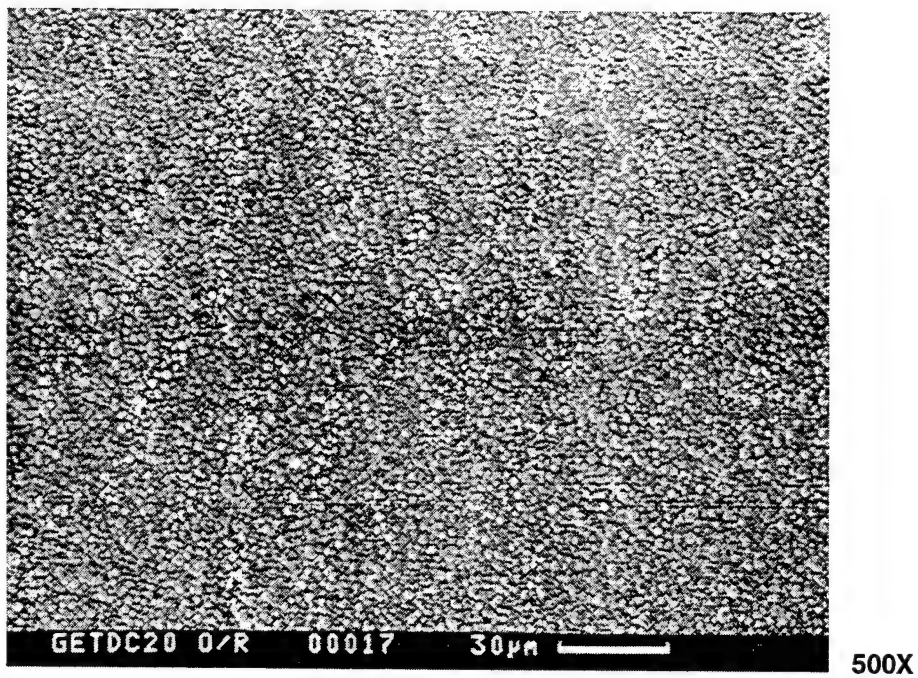
Figure 23. Thermal Shock Specimen GE TDC 20 SEM Photo of Position 2 (90°) in Shoulder (MRC Round 1). *TDC is in good condition.*

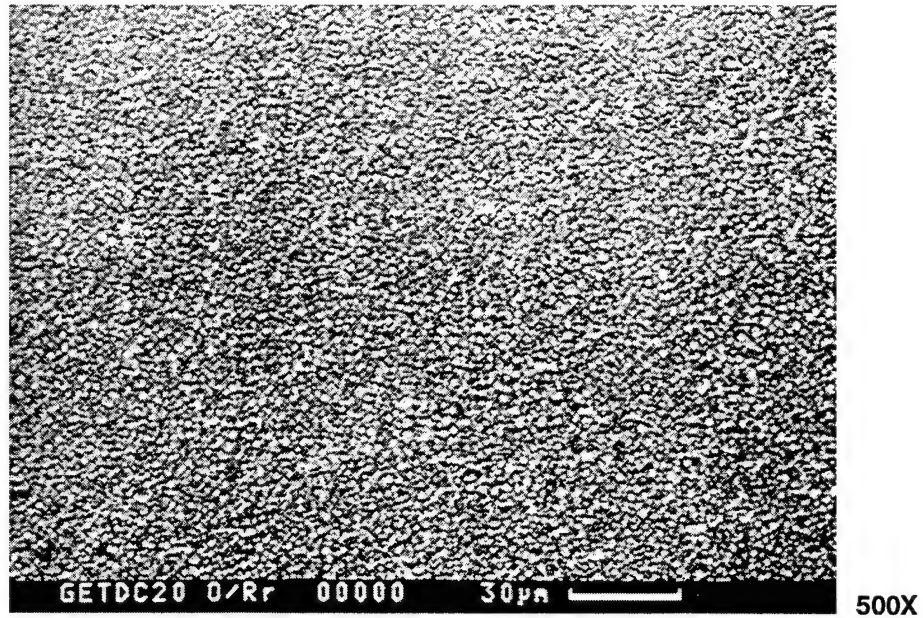
Figure 24. Thermal Shock Specimen GE TDC 20 SEM Photo of Position 3 (180°) in Raceway (MRC Round 1). *TDC is in good condition.*

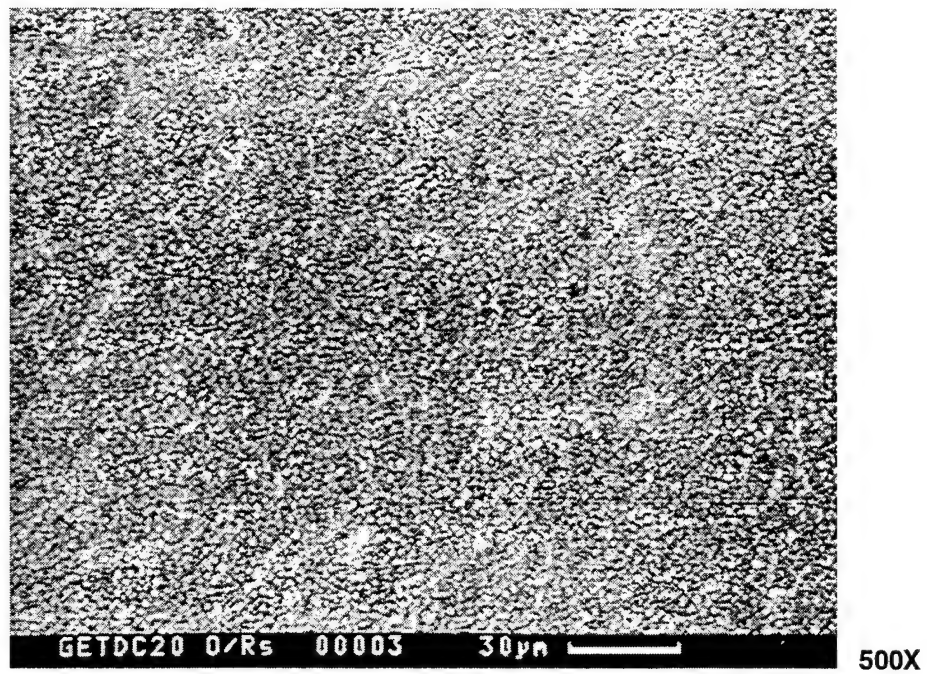
Figure 25. Thermal Shock Specimen GE TDC 20 SEM Photo of Position 3 (180°) in Shoulder (MRC Round 1). *TDC is in good condition.*

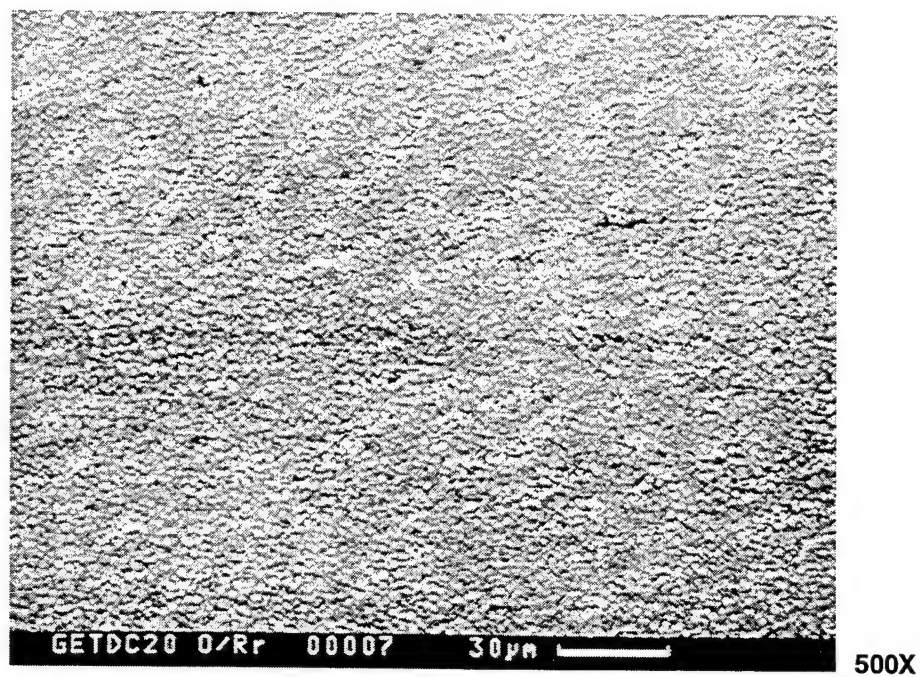
Figure 26. Thermal Shock Specimen GE TDC 20 SEM Photo of Position 4 (270°) in Raceway (MRC Round 1). *TDC is in good condition.*

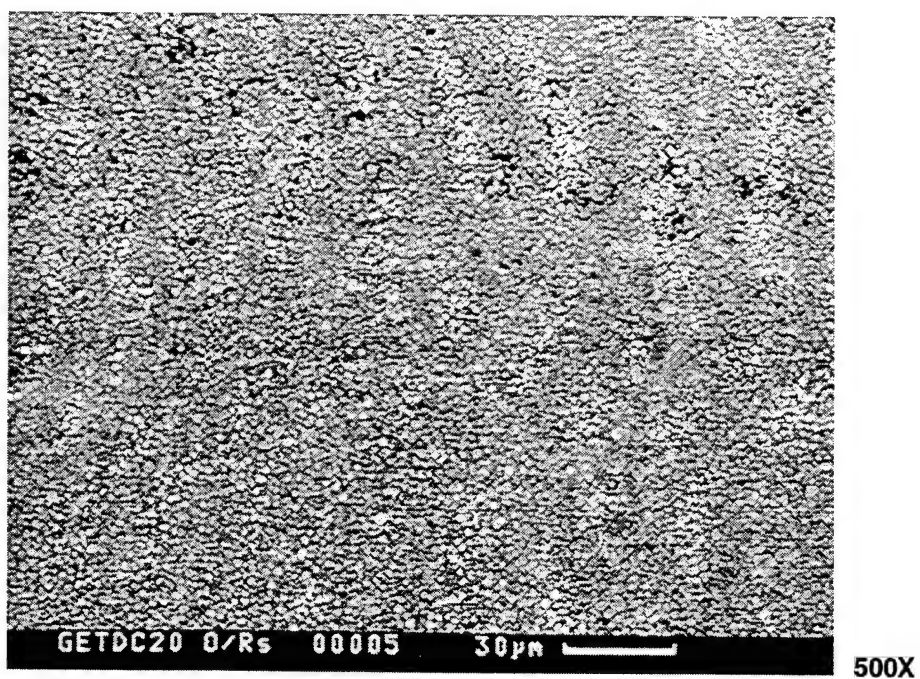
Figure 27. Thermal Shock Specimen GE TDC 20 SEM Photo of Position 4 (270°) in Shoulder (MRC Round 1). *TDC is in good condition.*

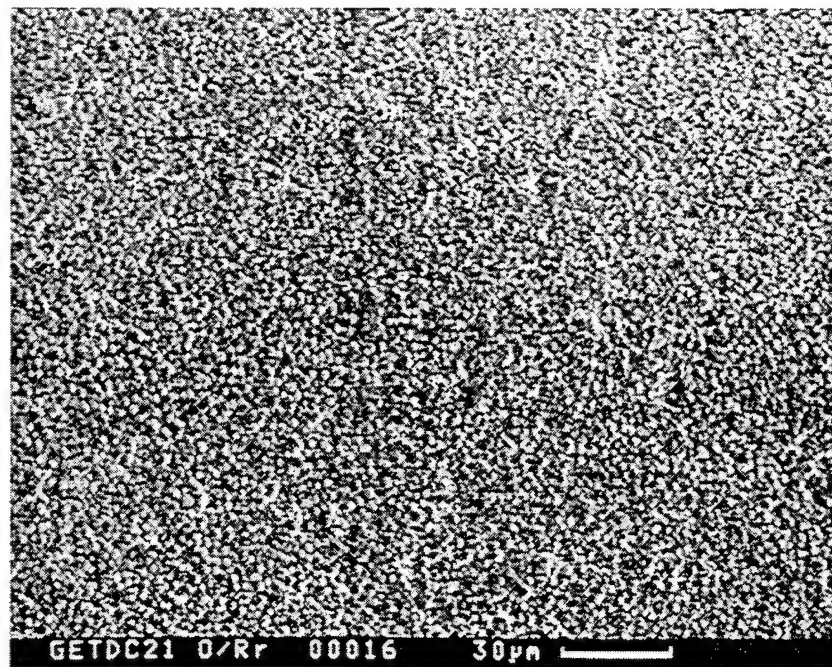
500X

Figure 28. Thermal Shock Specimen GE TDC 21 SEM Photo of Position 1 (0°) in Raceway (MRC Round 1). *TDC is in good condition.*

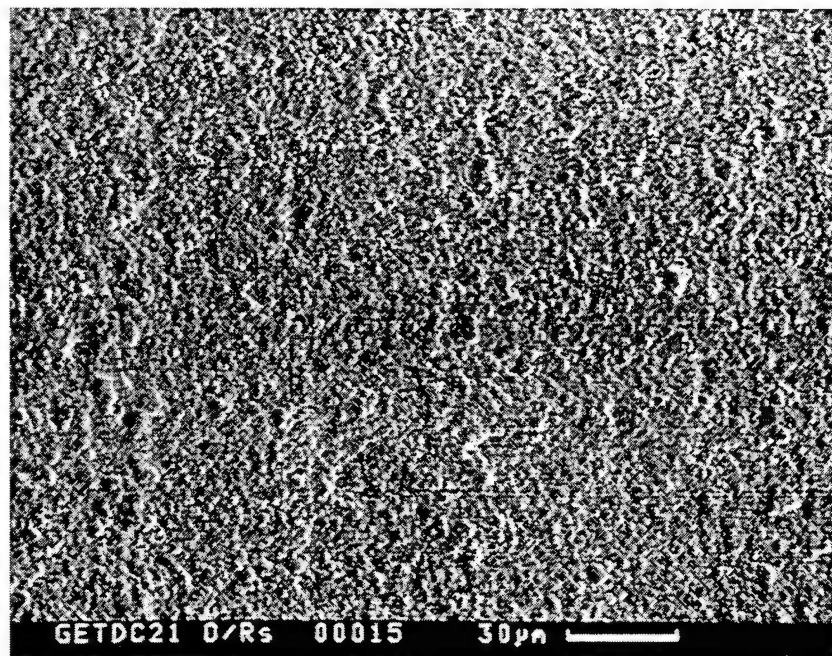
500X

Figure 29. Thermal Shock Specimen GE TDC 21 SEM Photo of Position 1 (0°) in Shoulder (MRC Round 1). *TDC is in good condition.*

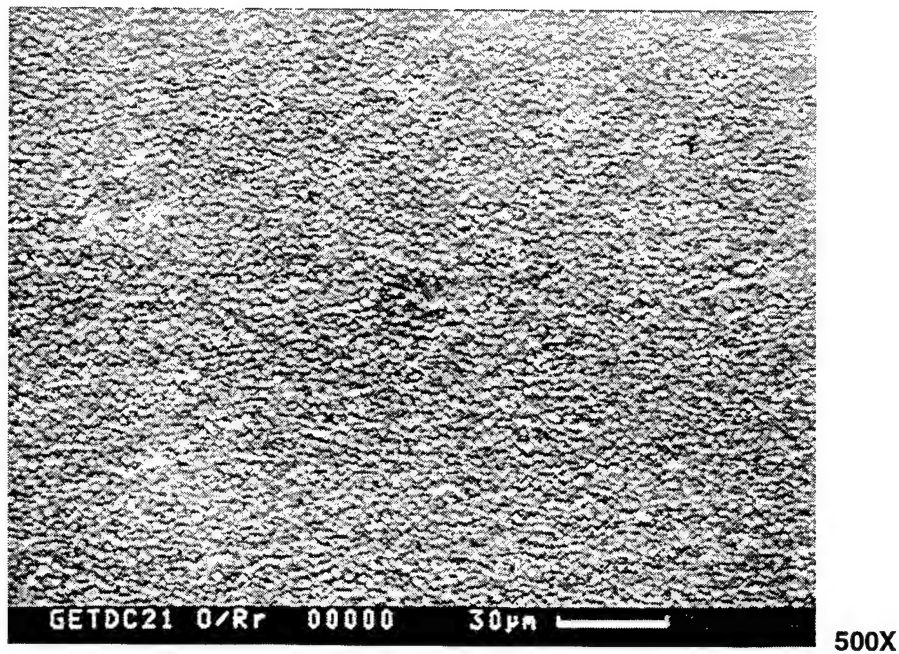
Figure 30. Thermal Shock Specimen GE TDC 21 SEM Photo of Position 2 (90°) in Raceway (MRC Round 1). *TDC is in good condition.*

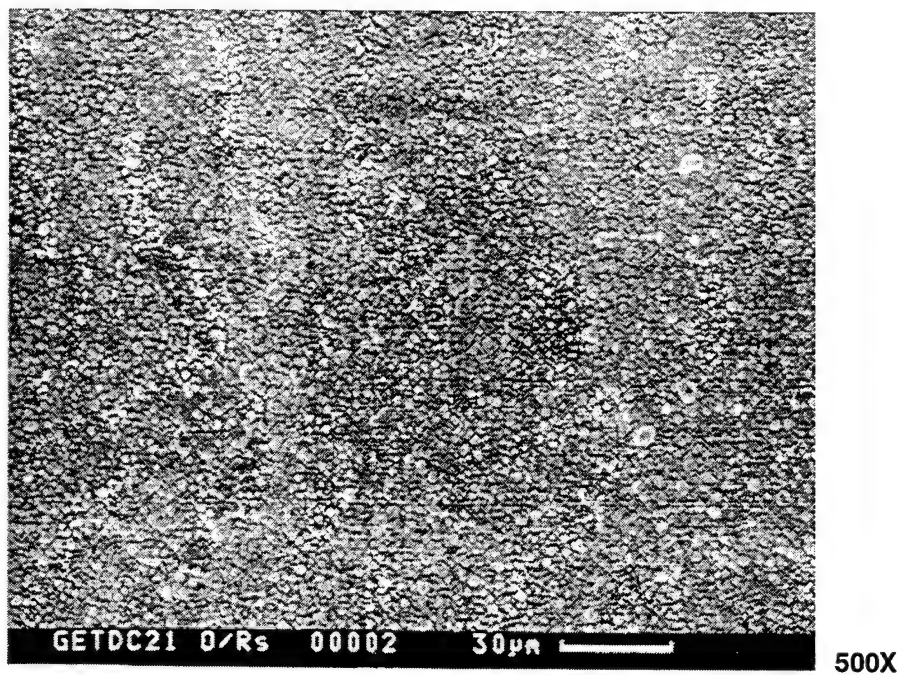
Figure 31. Thermal Shock Specimen GE TDC 21 SEM Photo of Position 2 (90°) in Shoulder (MRC Round 1). *TDC is in good condition.*

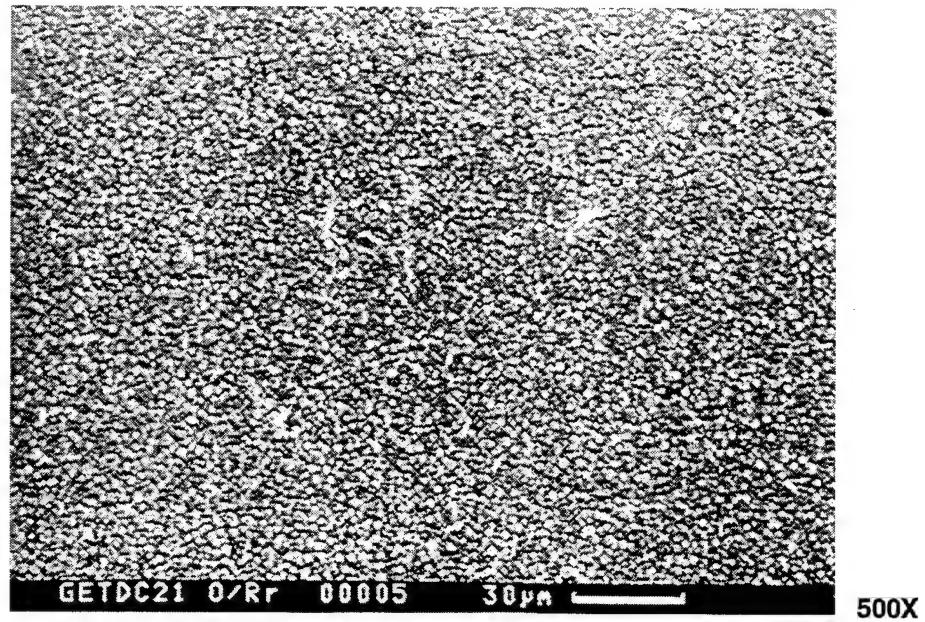
Figure 32. Thermal Shock Specimen GE TDC 21 SEM Photo of Position 3 (180°) in Raceway (MRC Round 1). *TDC is in good condition.*

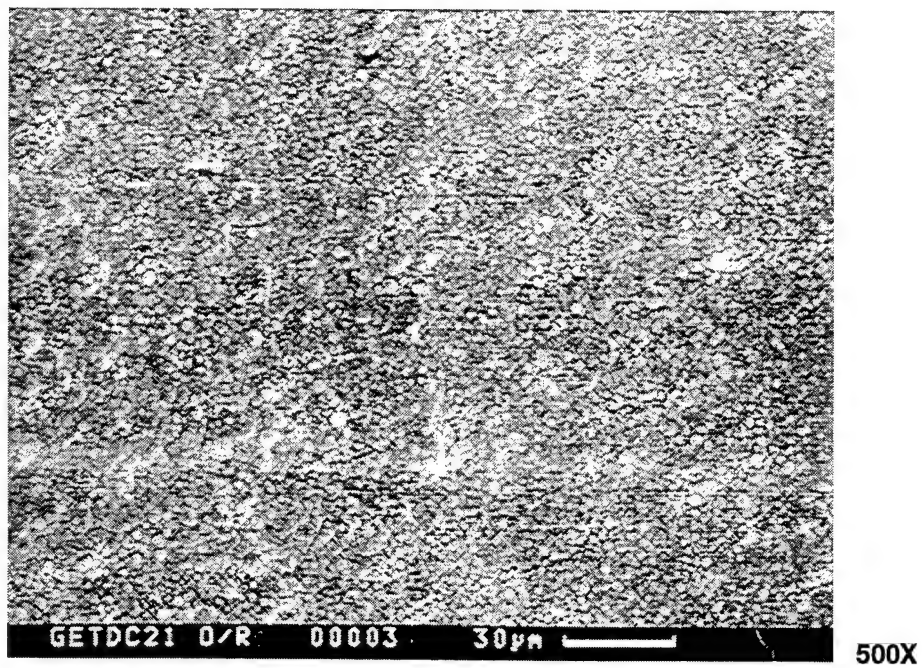
Figure 33. Thermal Shock Specimen GE TDC 21 SEM Photo of Position 3 (180°) in Shoulder (MRC Round 1). *TDC is in good condition.*

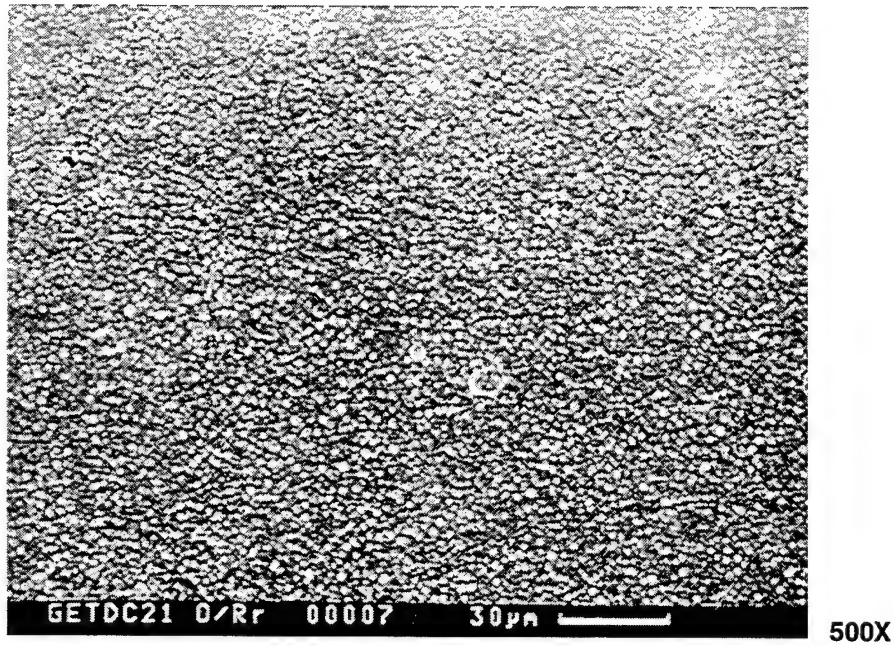
Figure 34. Thermal Shock Specimen GE TDC 21 SEM Photo of Position 4 (270°) in Raceway (MRC Round 1). *TDC is in good condition.*

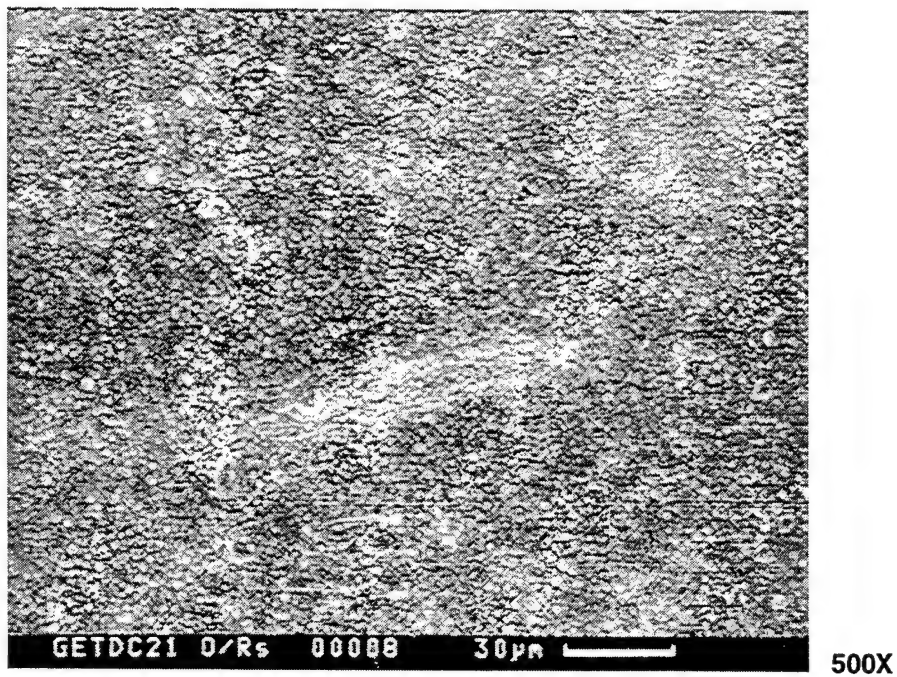
Figure 35. Thermal Shock Specimen GE TDC 21 SEM Photo of Position 4 (270°) in Shoulder (MRC Round 1). *TDC is in good condition.*

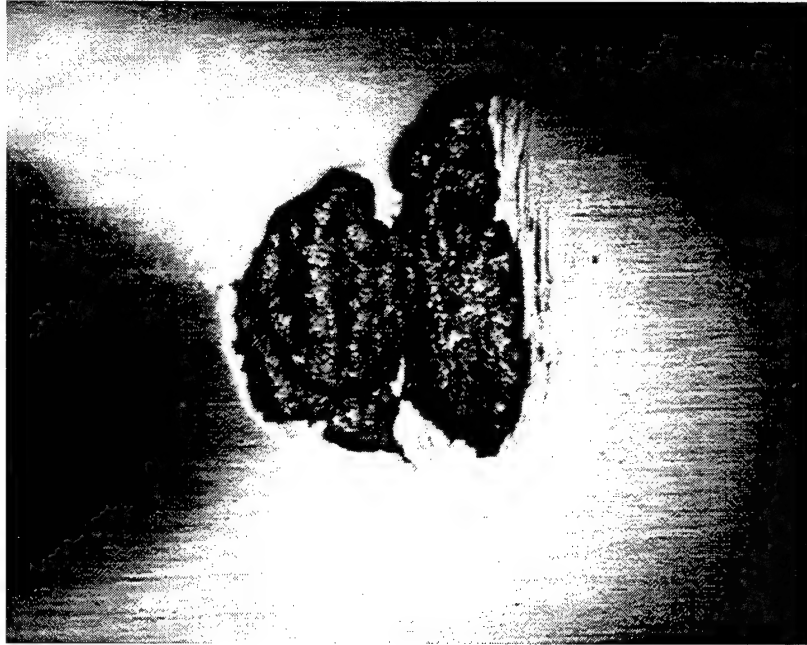
10X

Figure 41. SEM Photo of GE TDC 32 Inner Ring Spall from MRC Round 1.
Baseline plain bearing, 250 hours, only plain bearing failure.

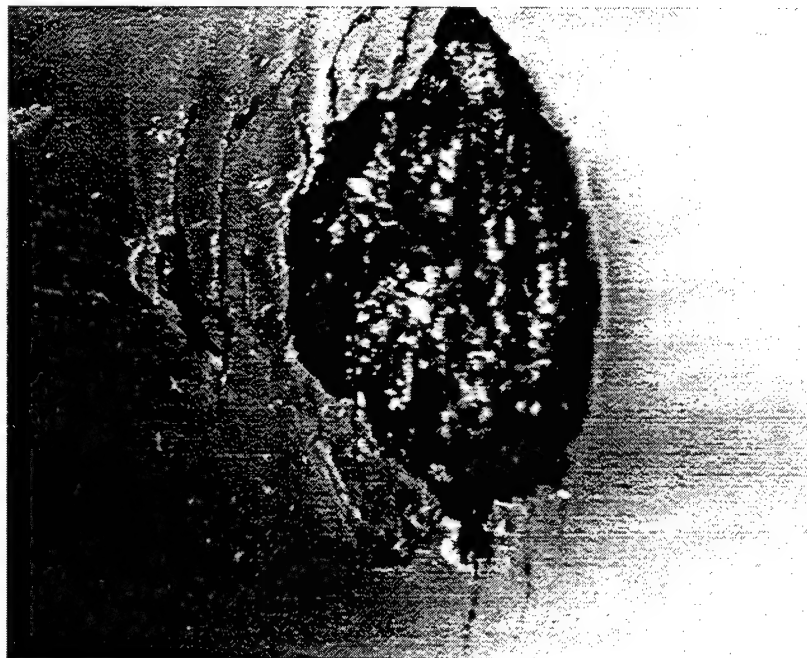
30X

Figure 42. SEM Photo of GE TDC 24 Inner Ring Spall from MRC Round 1.
TDC plated bearing, 876 hours, one of three plated bearing failures.

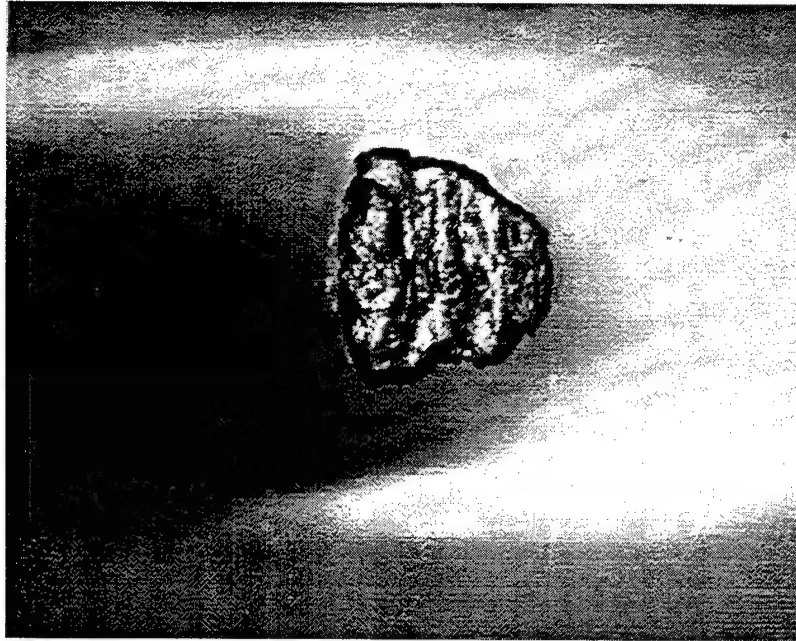
10X

Figure 43. SEM Photo of GE TDC 09 Inner Ring Spall from MRC Round 1.
TDC plated bearing, 2152 hours, one of three plated bearing failures.

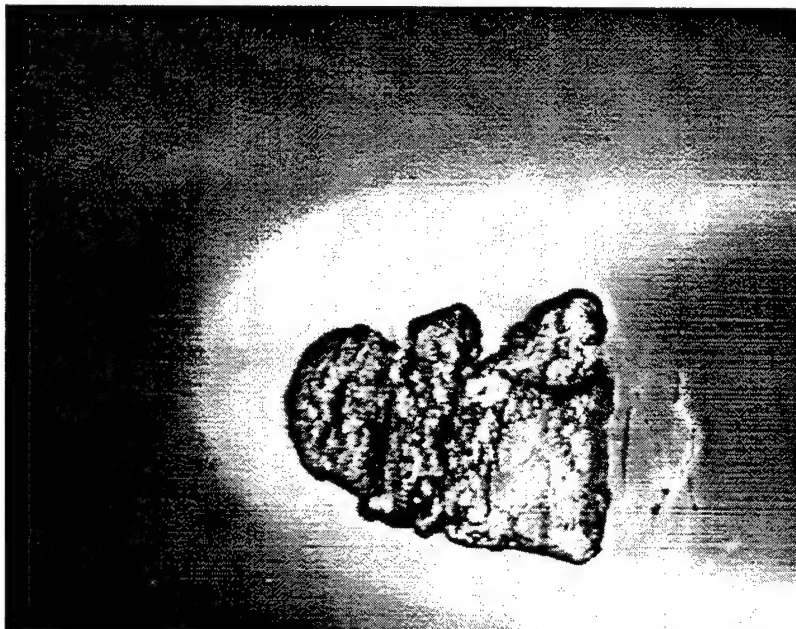
10X

Figure 44. SEM Photo of GE TDC 45 Inner Ring Spall from MRC Round 1.
TDC plated bearing, 802 hours, one of three plated bearing failures.

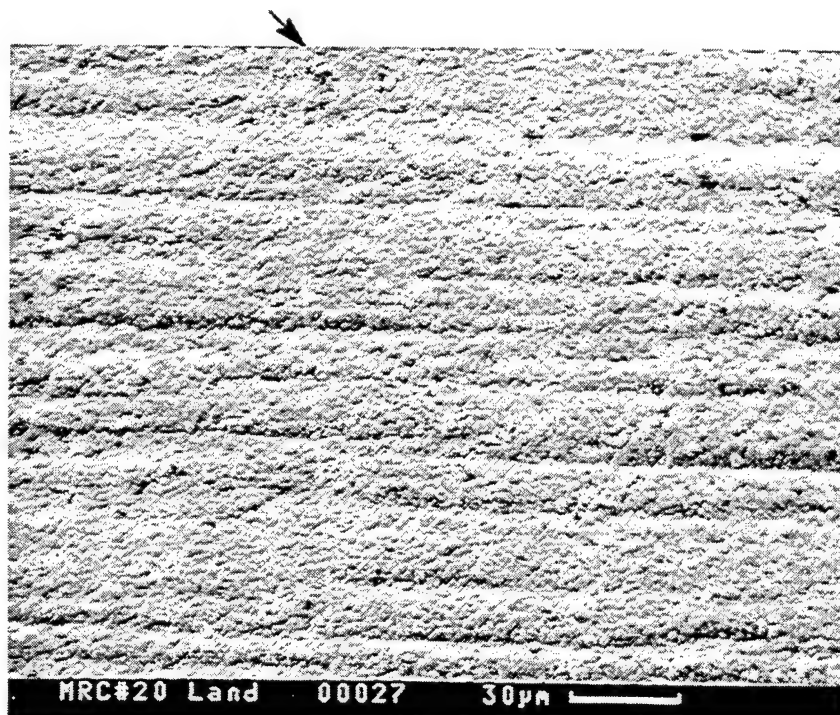
500X

Figure 50. SEM Photo of Bearing Land, SEI Mode.
Note crack in TDC coating.

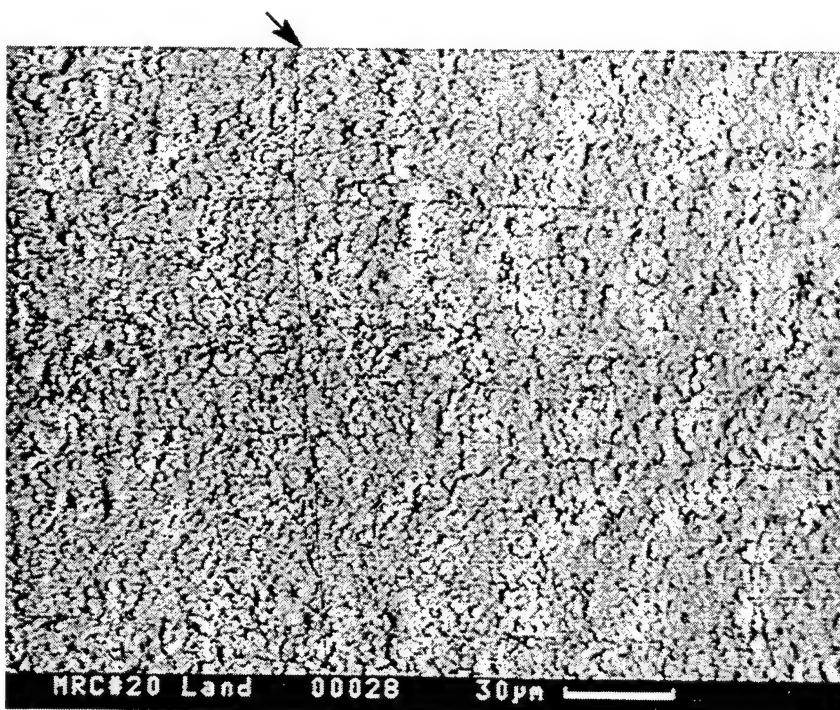
500X

Figure 51. SEM Photo of Bearing Land, BEI Mode.
Note crack in TDC coating.

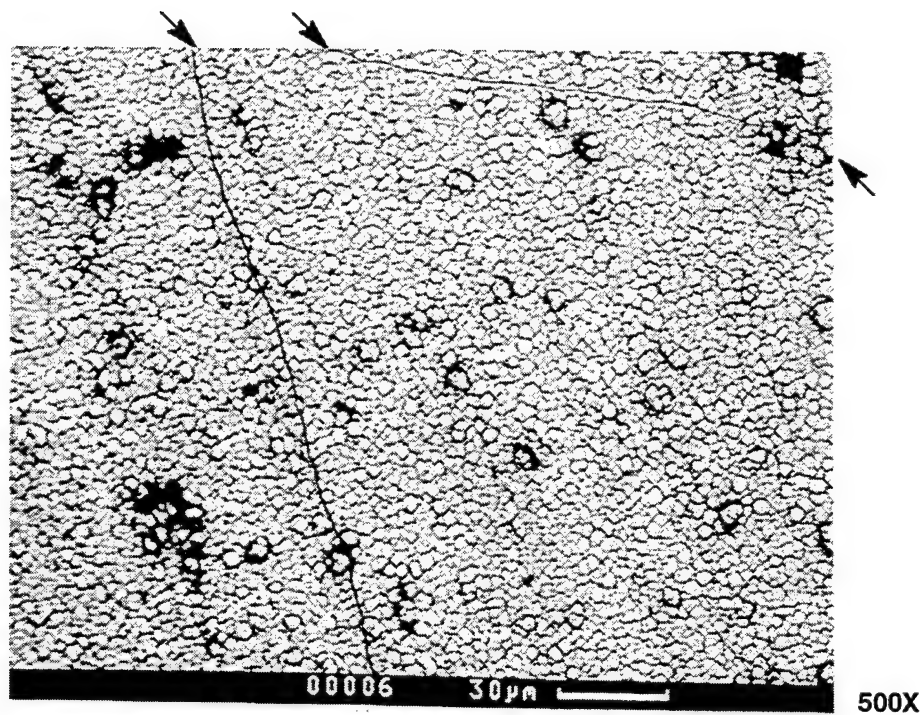
Figure 54. SEM Photo of Edge of Bearing Raceway Track, BEI Mode.
Note cracks.

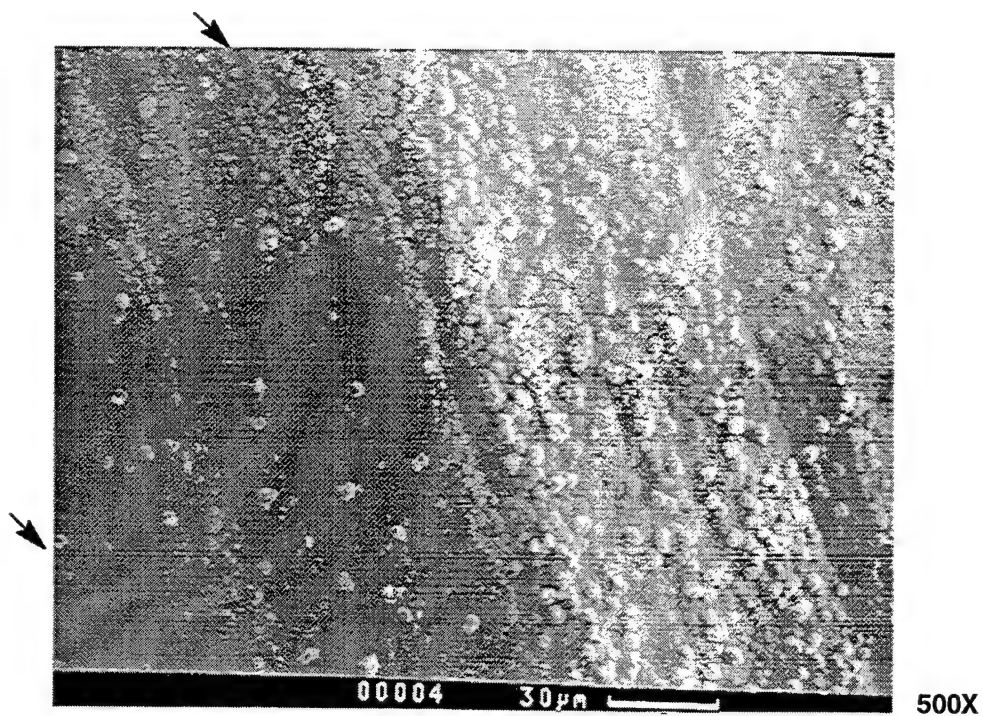
Figure 55. SEM Photo of Edge of Land No. 1, SEI Mode.
Note chrome clusters and cracks.

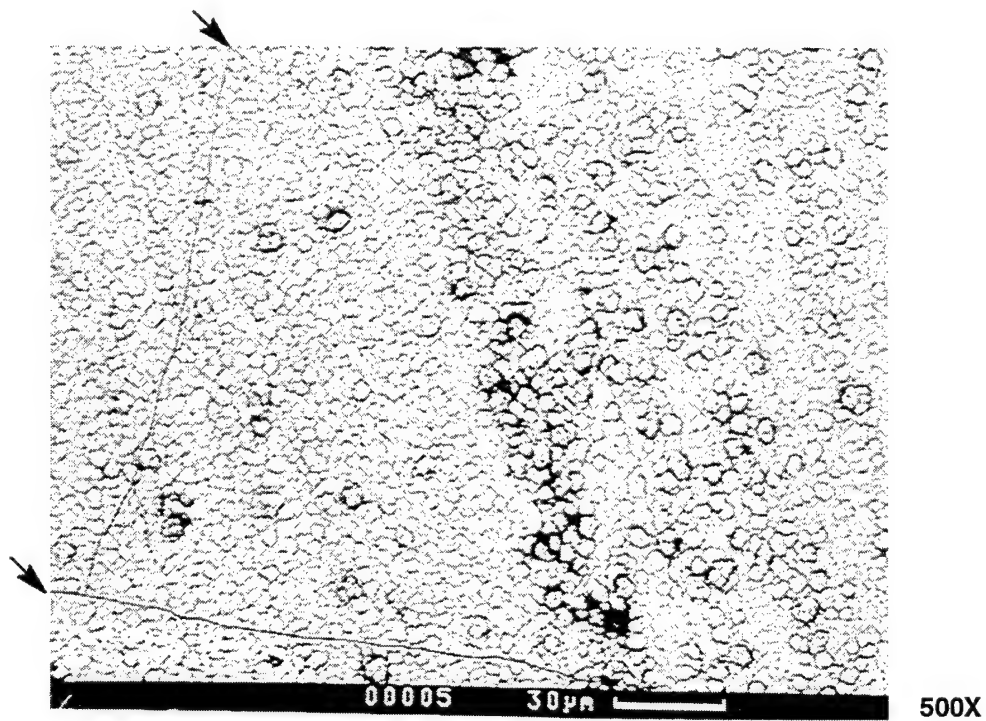
Figure 56. SEM Photo of Edge of Land No. 1, BEI Mode.
Note crack in same area as Figure 55 highlighted in BEI mode.

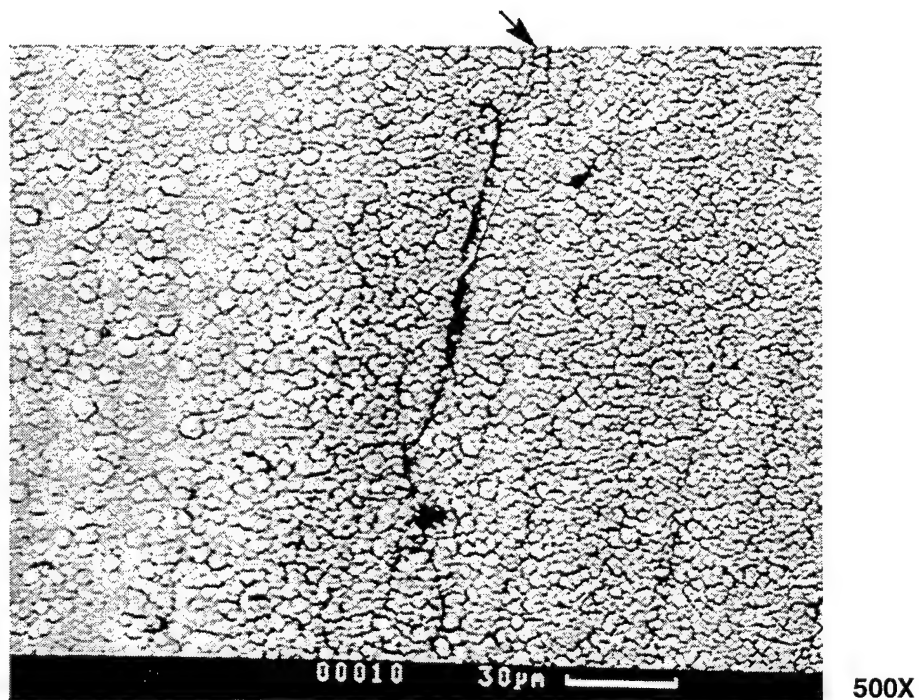
Figure 57. SEM Photo of Edge of Land No. 2, BEI Mode.
Note crack.

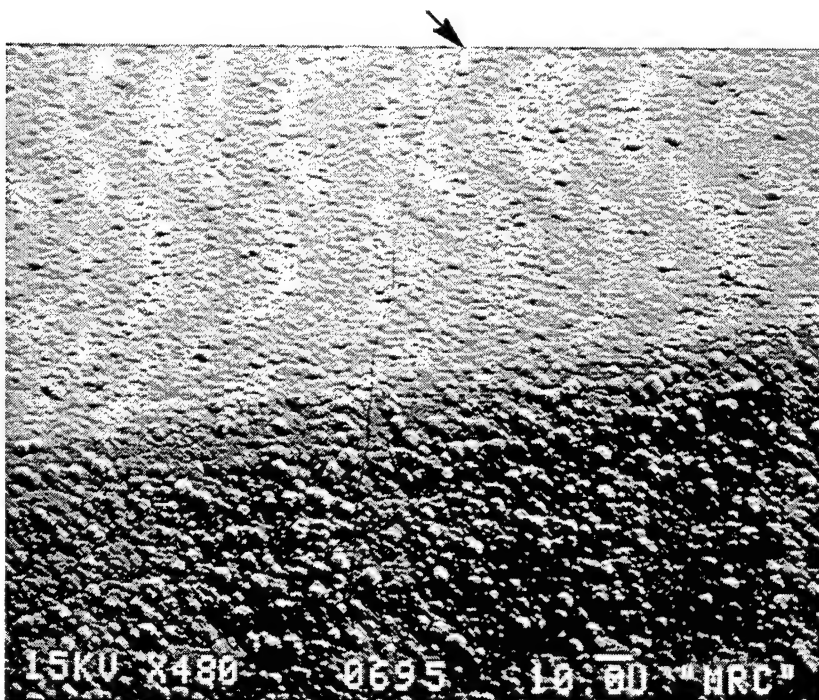
500X

Figure 66. SEM Photo of Raceway, 90°. *Note crack.*

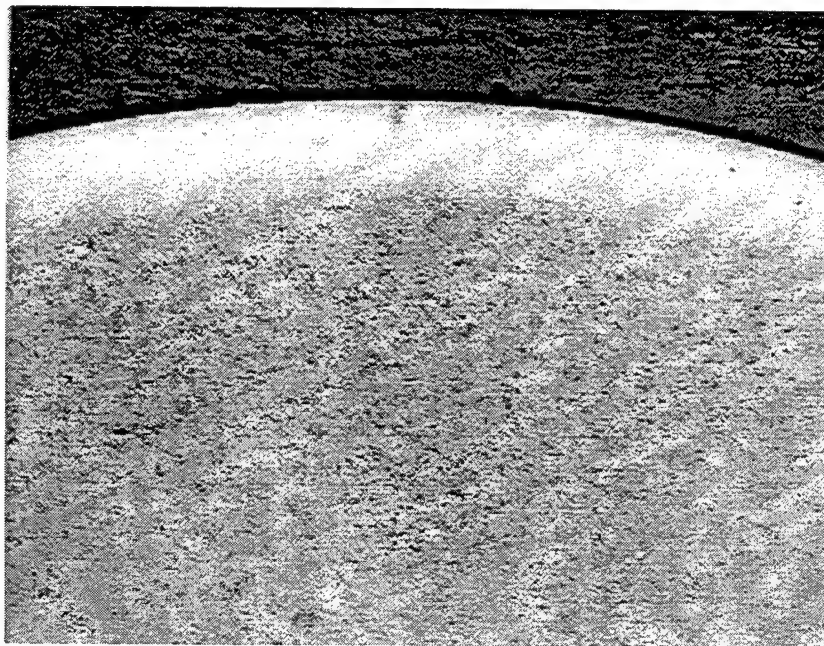
25X

Figure 72. Subsurface Stress Induced Microstructural Alteration (White Layer) in Ball from Round 2/Test 4. *The layer covered the entire ball indicating the ball was spinning.*

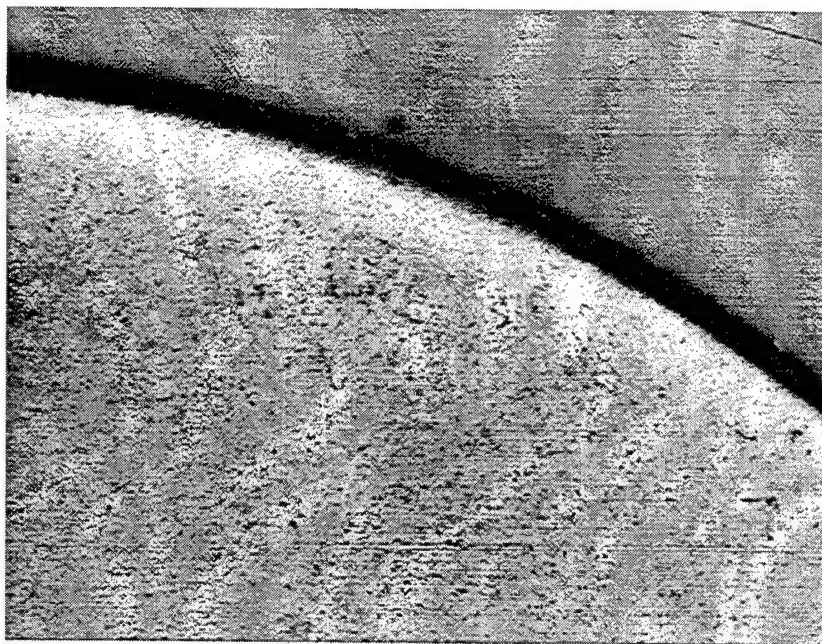
25X

Figure 73. Subsurface Stress Induced Microstructural Alteration (White Layer) in Ball from Round 2/Test 6. *The layer was in a circumferential line indicating the ball was tracking.*

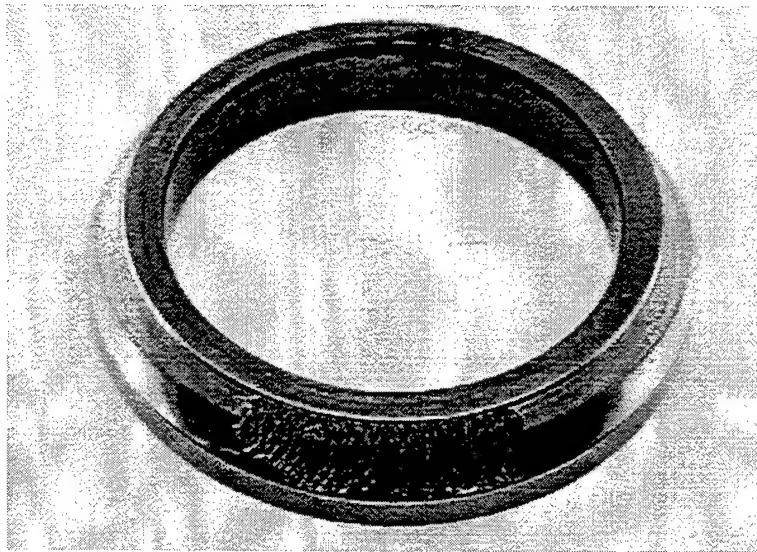
Two baseline (bare M50) failures occurred, one at 620 hours and the other at 4,030 hours. Five TDC coated bearings failed at 41, 225, 1,825, 2,293, and 2,710 hours. All failures were inner ring spalls. The estimated L10 calculation for the population based on this experiment was 2,943 hours for the baseline bearings and 519 hours for the TDC coated bearings. The TDC coated bearings L10 life clearly appeared inferior in RCF to the unplated baseline bearings. Figures 89 through 95 show both the failed baseline and TDC coated inner rings from this round of testing.

Figure 90. Photo of Plain Bearing Spall Which Failed at 4,030 Hours.

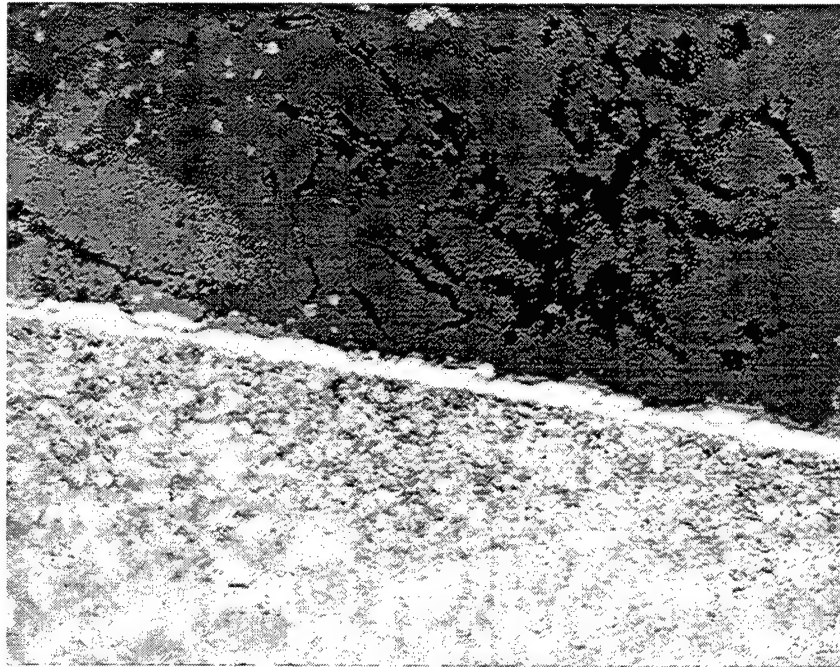
Figure 98. Optical Photomicrograph of Shoulder (Area 2) 125 μ m TDC Thickness.
Within specification.

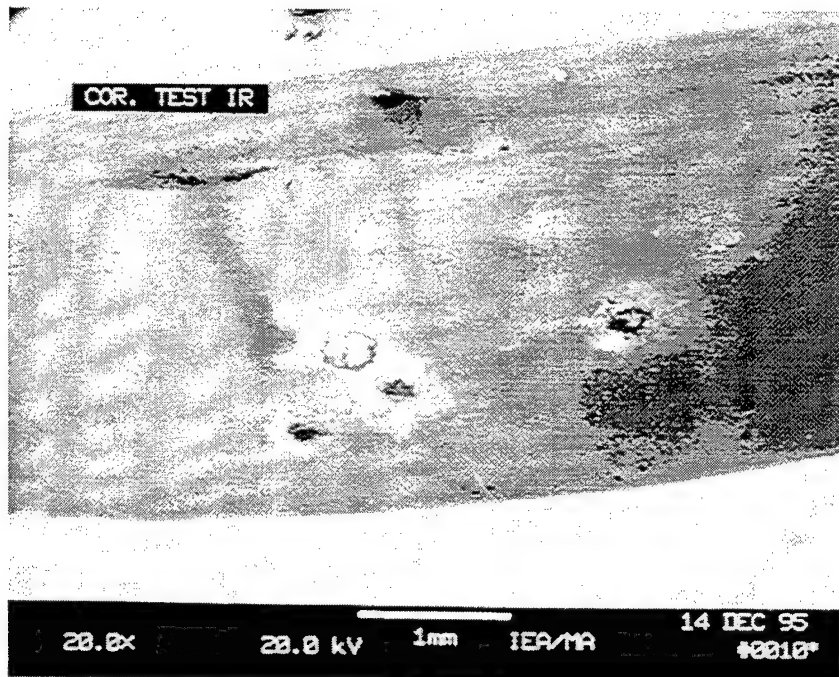
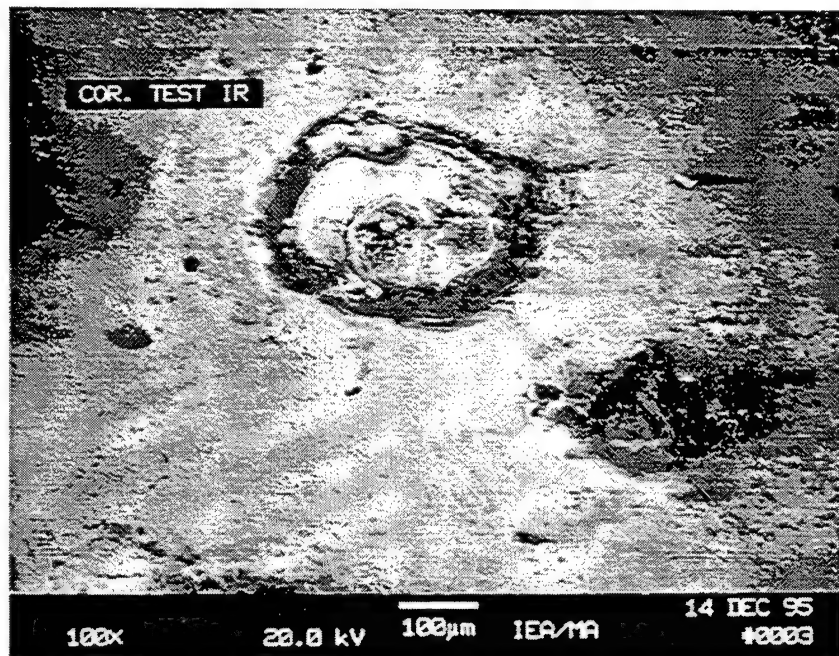
Figure 107. SEM Photomicrographs of Corrosion Test Pits on Bearing Shoulder.
Failed test.

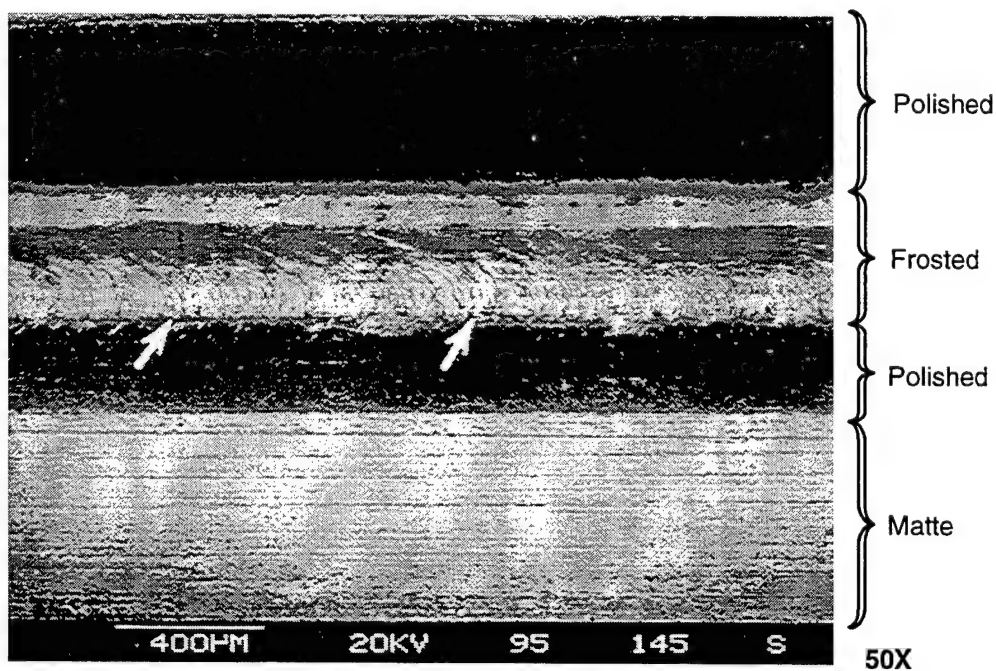
Figure 113. Photomicrograph of Frosted Band in Bearing S/N 0022.
Note distressed TDC from sliding ball in ball track (arrows).

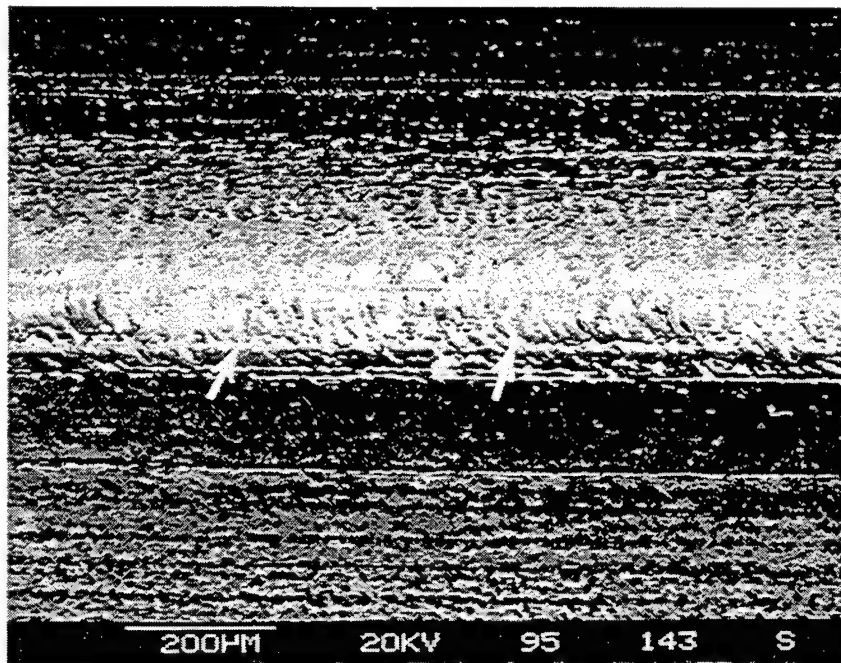
100X

Figure 114. Photomicrograph of Frosted Band in Bearing S/N 0025.
Note sliding type damage in ball track (arrows).

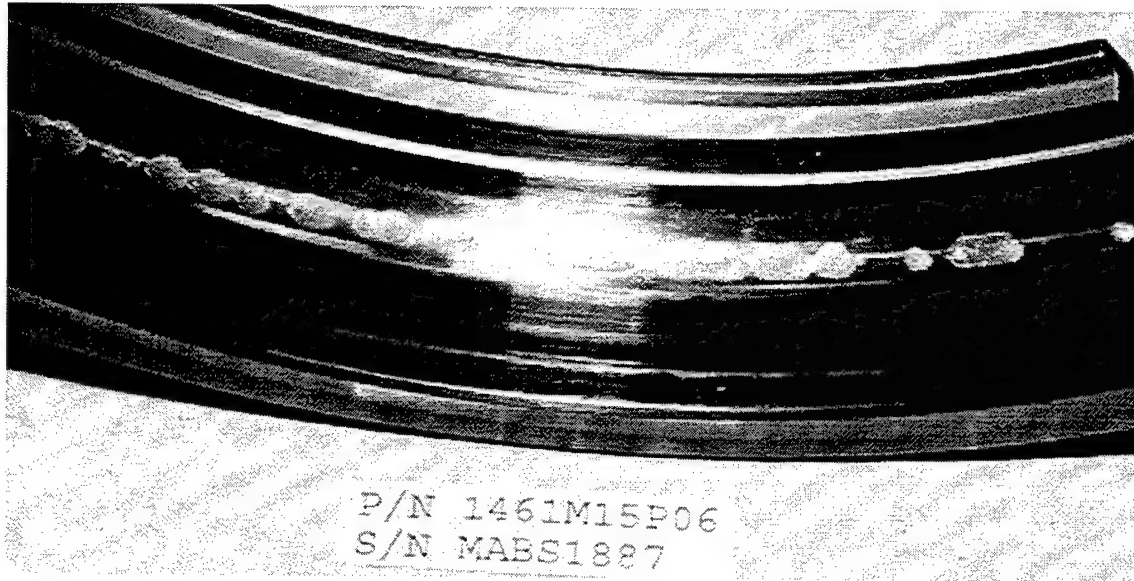
Figure 117. Photo of Outer Race Spalling on Bare, Contamination Tested Bearing.
Bare bearings have significantly less resistance to contamination.
